Reforming and Testing High Voltage Electrolytic Capacitors

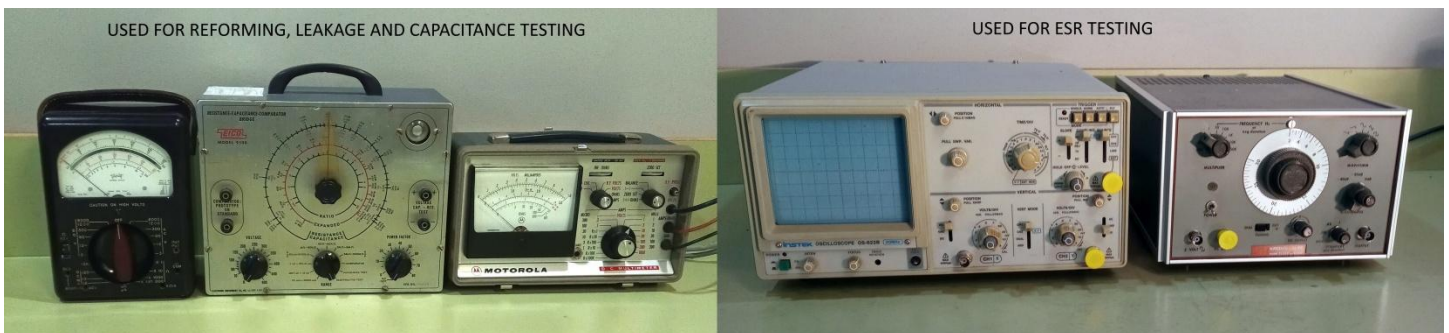
For the reforming I slowly increased the voltage on the capacitor while monitoring the current until the capacitor's maximum working voltage was reached and then waited until the current no longer decreased. This could take a while. I did not want the capacitor to draw to much current while reforming although the EICO cannot source a lot of current. This reforming differs from the more conventional approach of supplying the capacitor its rated working voltage through a current limiting resistor.
